Manhole Inspection Summary

Manhole # S29M__047MH

Insp Date: **12/4/08 10:52 AM**

Location Address: **800 Scott St.**

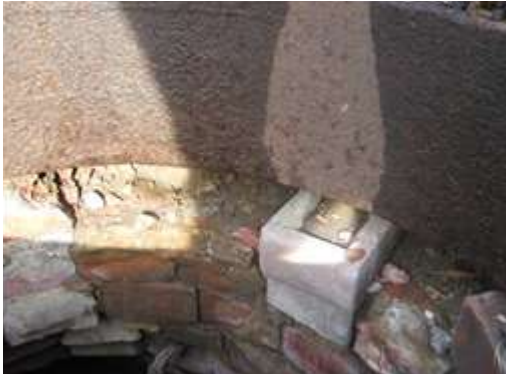
Miscellaneous

Condition: ☐ Sound ☐ Cracked ☐ Root Intrusion ☒ **Loose Brick** ☒ **Deteriorated**

Infiltration: ☐ None ☐ Joint ☐ Cracks ☒ **Mortar** ☐ Roots ☐ Wall

missing bricks with chimney infiltration

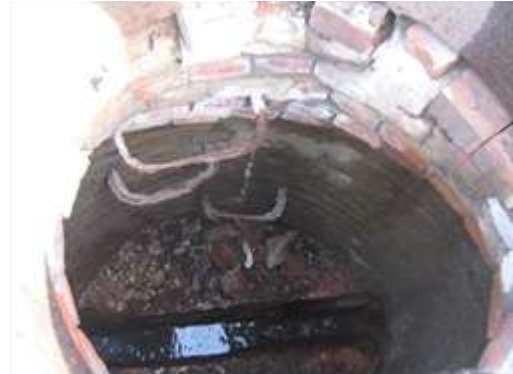
Miscellaneous

Infiltration: ☐ None ☐ Joint ☐ Cracks ☐ Mortar ☐ Roots ☒ **Wall**

Steps Count: **3** Missing: **0** ☒ **Corroded**

corbel infiltration and corroded steps

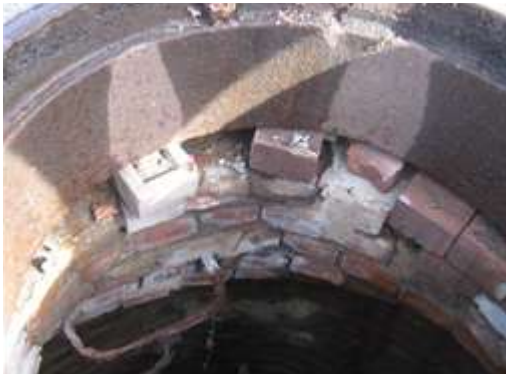
Defect 3

chimney loose brick & deteriorated with infiltration from mortar, infiltration from corbel wall, corroded steps

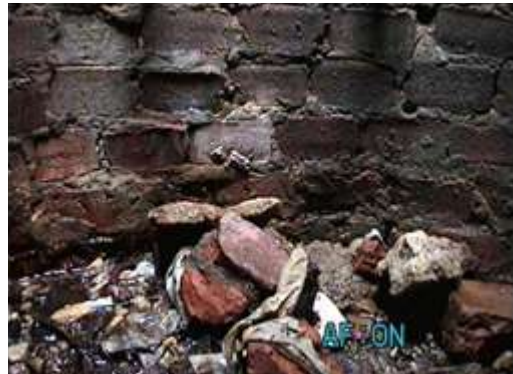
Defect 2

Condition: ☐ Sound ☐ Cracked ☐ Root Intrusion ☐ Deteriorated ☐ Leaks ☒ **Debris**

debris on the bench

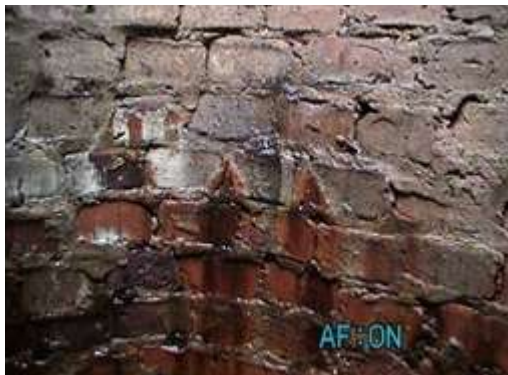
Defect 1

Infiltration: ☐ None ☐ Joint ☐ Cracks ☐ Mortar ☐ Roots ☒ **Wall**

active barrel infiltration from wall

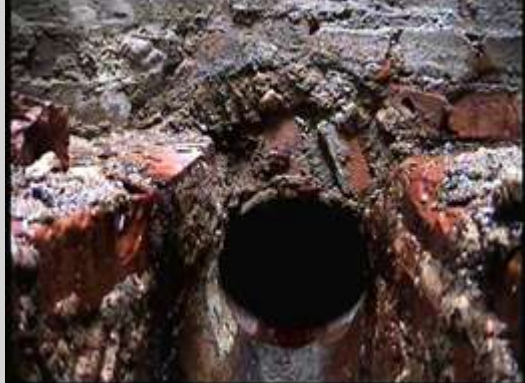
12 O'Clock Outflow

Pipe Height: **8.4** (in.) Rod and Bar (Angled)
Pipe Material: **Clay** ☐ Pipe Lined
Invert Depth: **6.82** (ft.) Flow Characteristics: **None**
Deposits: ☒ None ☐ Mud ☐ Sludge ☐ Debris ☐ Grease
Silt Depth: **0** (in.) Deposits Extent:
Infiltration: **None** Pipe Seal Cond: **Sound**

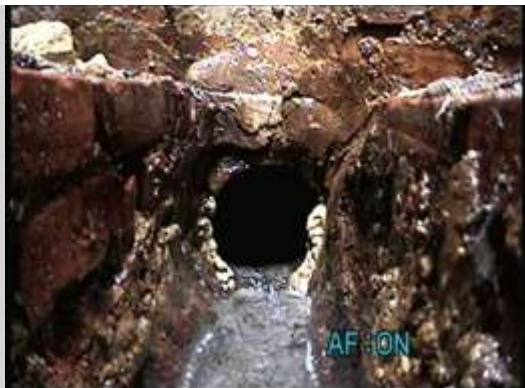
6 O'Clock Inflow

Pipe Height: **6** (in.) Rod and Bar (Angled)
Pipe Material: **Clay** ☐ Pipe Lined
Invert Depth: **6.76** (ft.) Flow Characteristics: **None**
Deposits: ☒ None ☐ Mud ☐ Sludge ☐ Debris ☐ Grease
Silt Depth: **0** (in.) Deposits Extent:
Infiltration: **None** Pipe Seal Cond: **Sound**
